## Site Features Inventory Report

**Barite Hill Mine  
McCormick, South Carolina**

Prepared By: Michael Gobla, P.E.

July 2007

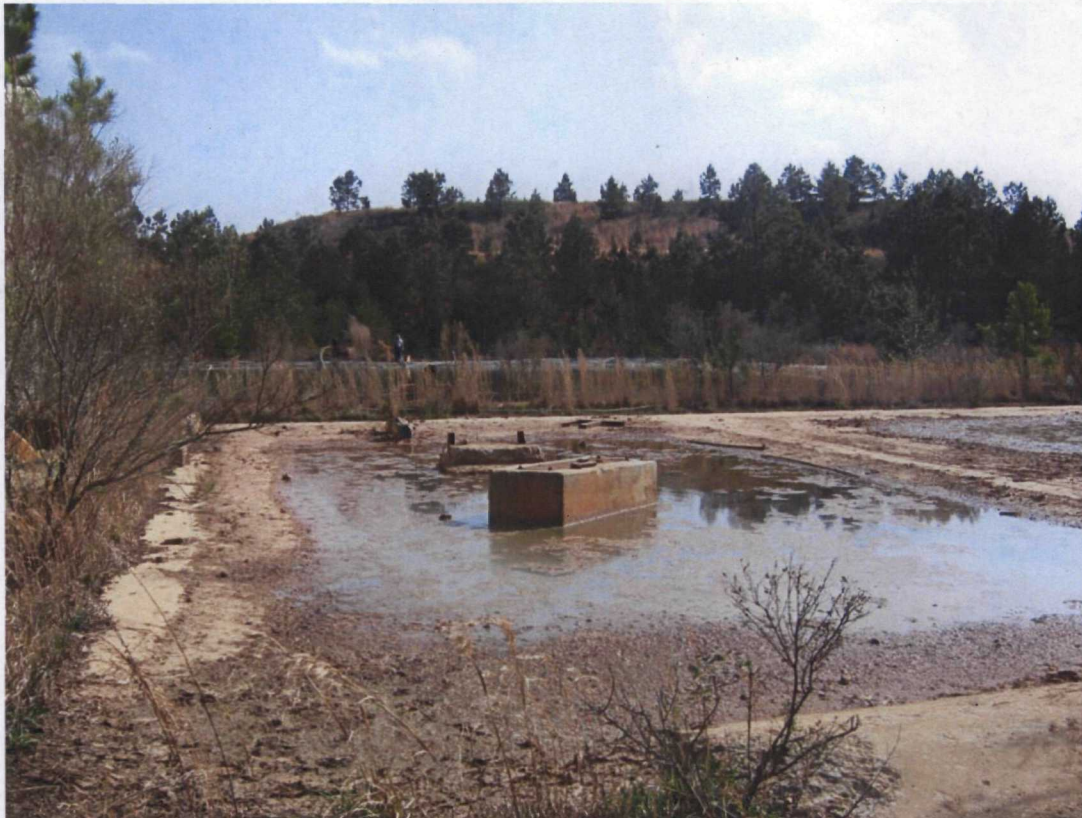
At present, only the foundations for the Process Plant remain. As can be seen in the accompanying photograph, the foundation included a concrete slab with bermed edges for spill containment. This containment would have overflowed to the adjacent process ponds in the event of a large spill. No significant issues are associated with these foundations.

**Figure 44. Photograph of the foundations remaining at the Process Plant area.**

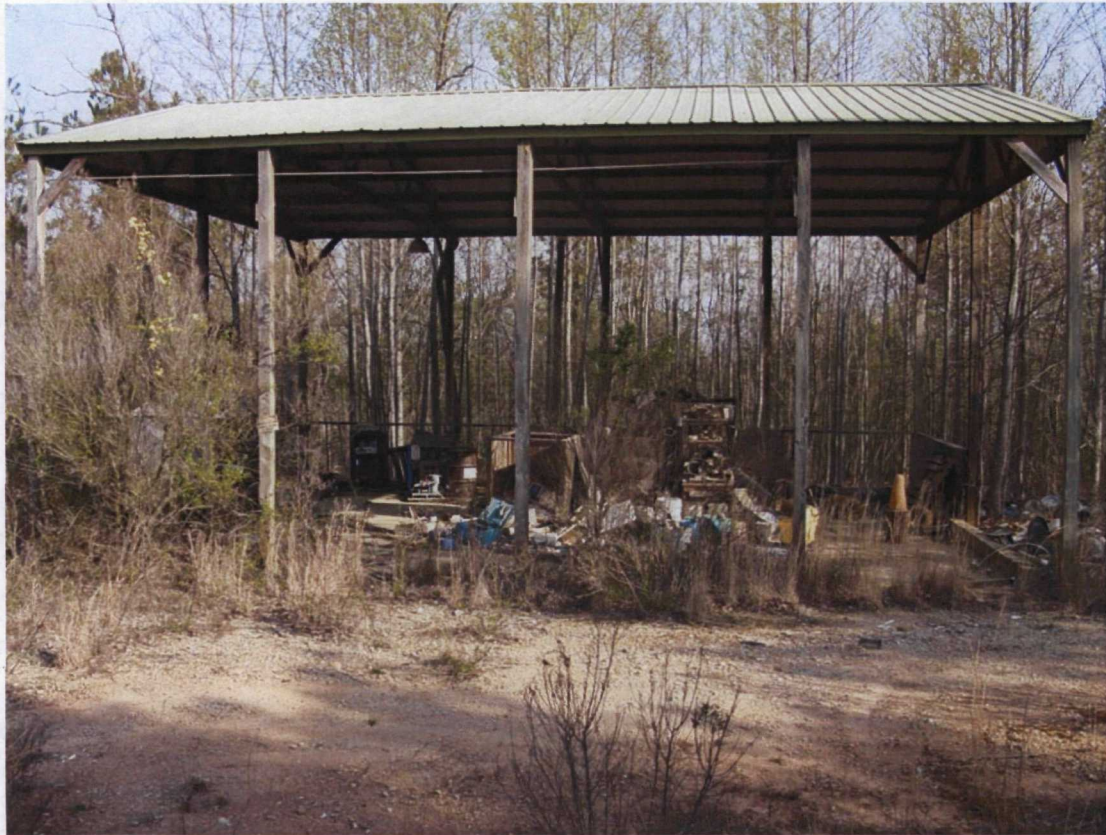
This structure was used to store materials during site operations. At present there is a variety of inert debris including a 55-gallon drum filled with steel wool, broken glass, plastic, and cardboard. Several sacks of cement are present, but exposure to the elements has hydrated them. A 55-gallon drum labeled "Methyl-ethyl Keytone" was sampled by others for analysis.

**Figure 45. The Pole Barn storage shed facility.**

There are many boards with protruding nails on the ground in and adjacent to the Pole Barn. The wood, glass, and other inert debris should be disposed of.

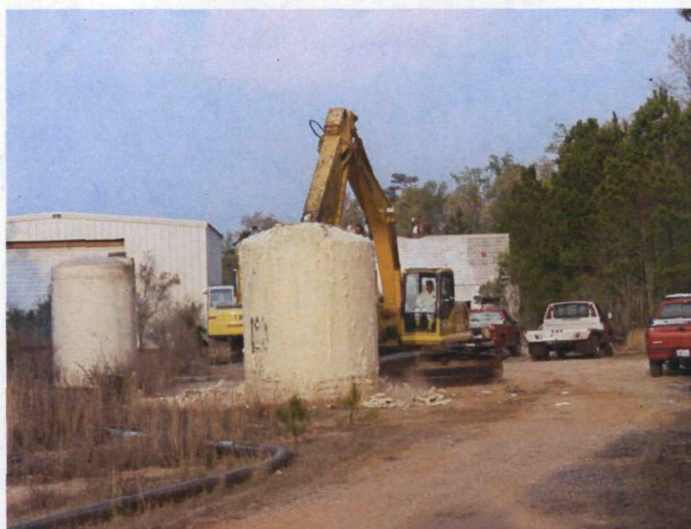
**Figure 46.** Removing foam insulation from the 3,000 gallon tank containing caustic prior to taking it to the pit. Another tank is seen to the left.

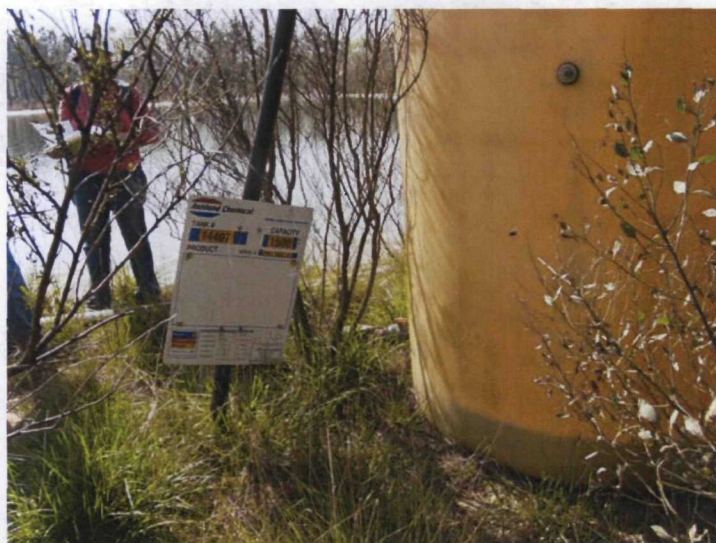
**Figure 47.** Tank next to the Permanent Heap Barren Pond was used for make up cyanide solution. The fluid was sampled for analysis by others.

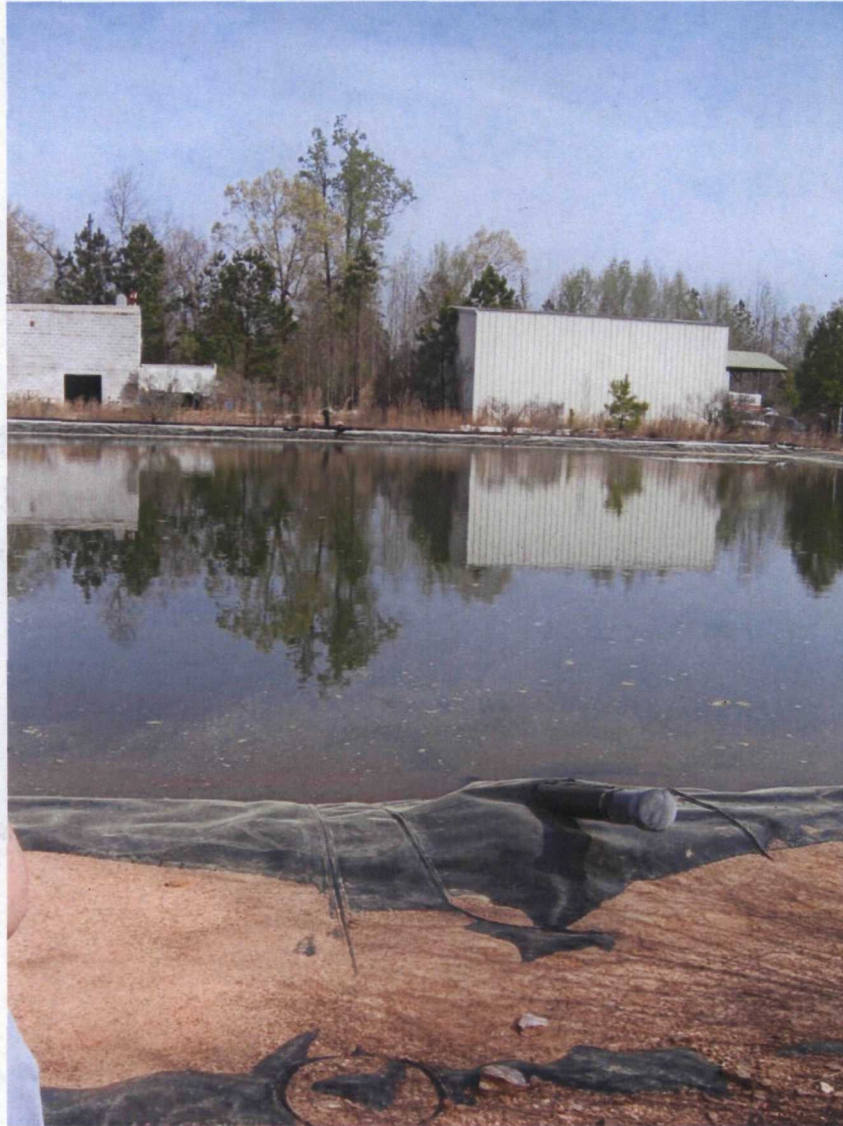
The Process Plant Barren Pond was used to contain cyanide solution discharged from the Process Plant carbon columns after it passes through the Process Plant Carbon Pond. The carbon columns remove the gold from the pregnant cyanide solution thus rendering the solution "barren." The pond is 140 ft. wide by 140 ft. long. This pond is full and precipitation results in overflow to the Process Plant Rinse Pond.

**Figure 52. Photograph showing the Process Plant Barren Pond and leak detection sump riser pipe.**

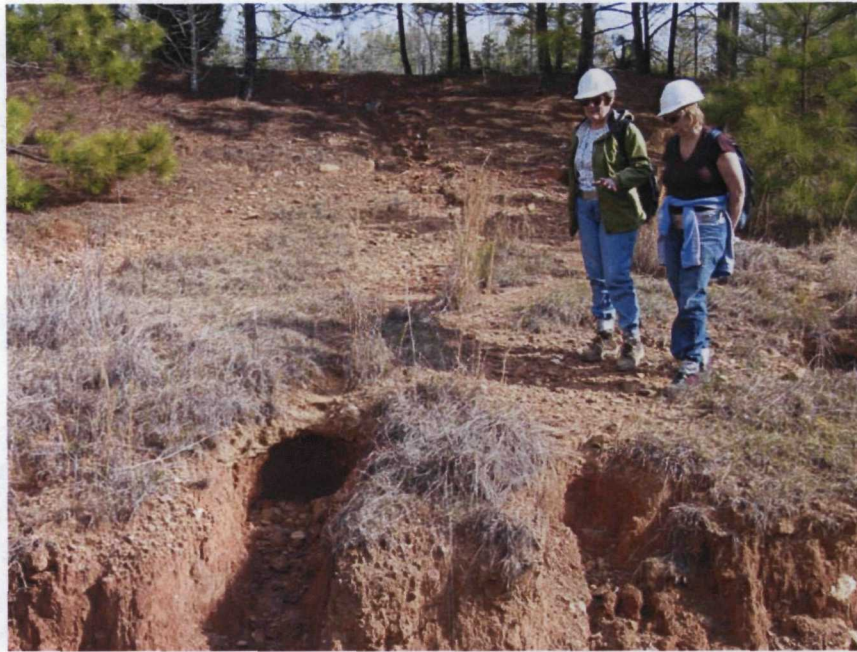
**Figure 56. Signs of erosion and piping of the outslope of the fill embankment supporting the contingency pond.**

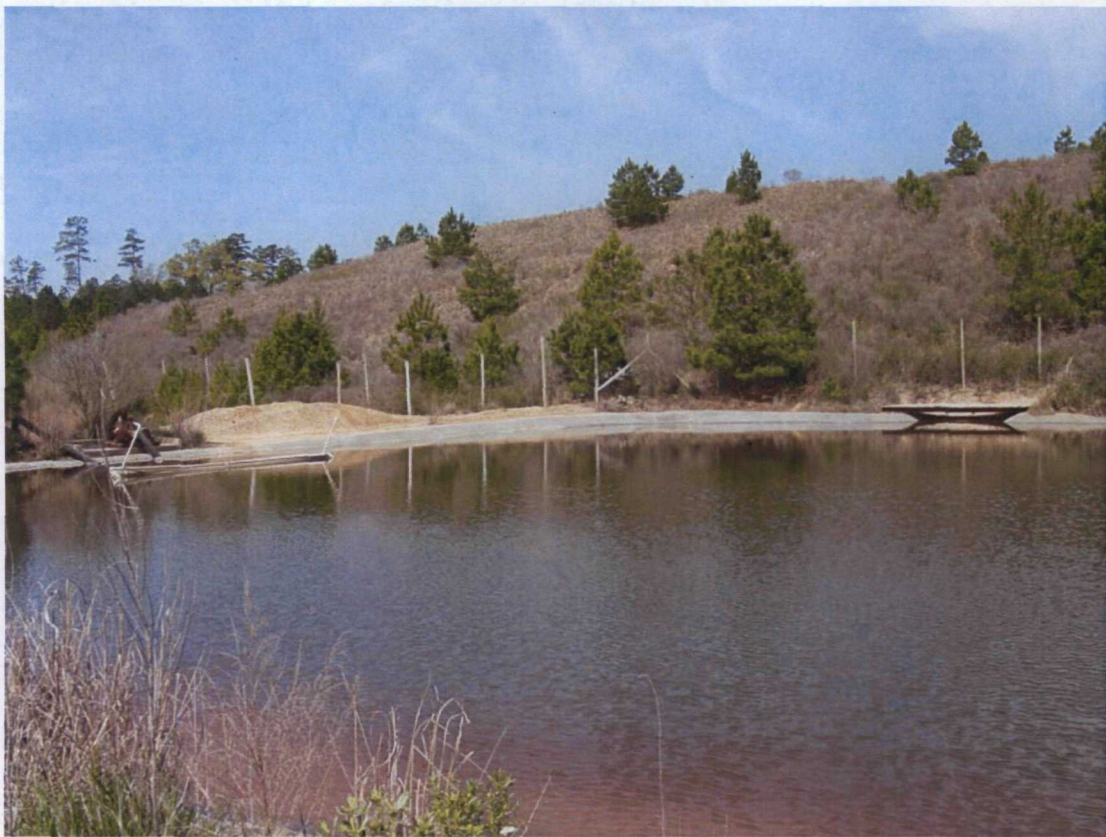
Labeled as a Pregnant / Rinse Pond on design drawings, the Permanent Heap Pregnant Pond was constructed in the fall of 1992 (Westec, 1992). The pond has a 30-mil-thick PVC bottom liner and a 40-mil-thick UV resistant PVC upper liner. Between these two liners is a geonet drain leading to a gravel-filled leak detection sump. An 8-inch diameter PVC perforated drain pipe is placed in the sump and it is accessed by connection to a solid PVC pipe riser which penetrates the liners and is attached to them using boots. The fill around this pond appears to be acidic spent ore. Sampling by others indicates that the leak detection sump contains water with 30,000 ppb (30 ppm) cyanide and it needs to be neutralized.

**Figure 58. Photograph of the Permanent Heap Pregnant Pond looking towards the west. The southwest portion of the capped and reclaimed Permanent Heap forms the hillside in the background of the photograph. Note the small pile of acidic material adjacent to the pump station on the left side of the photograph.**

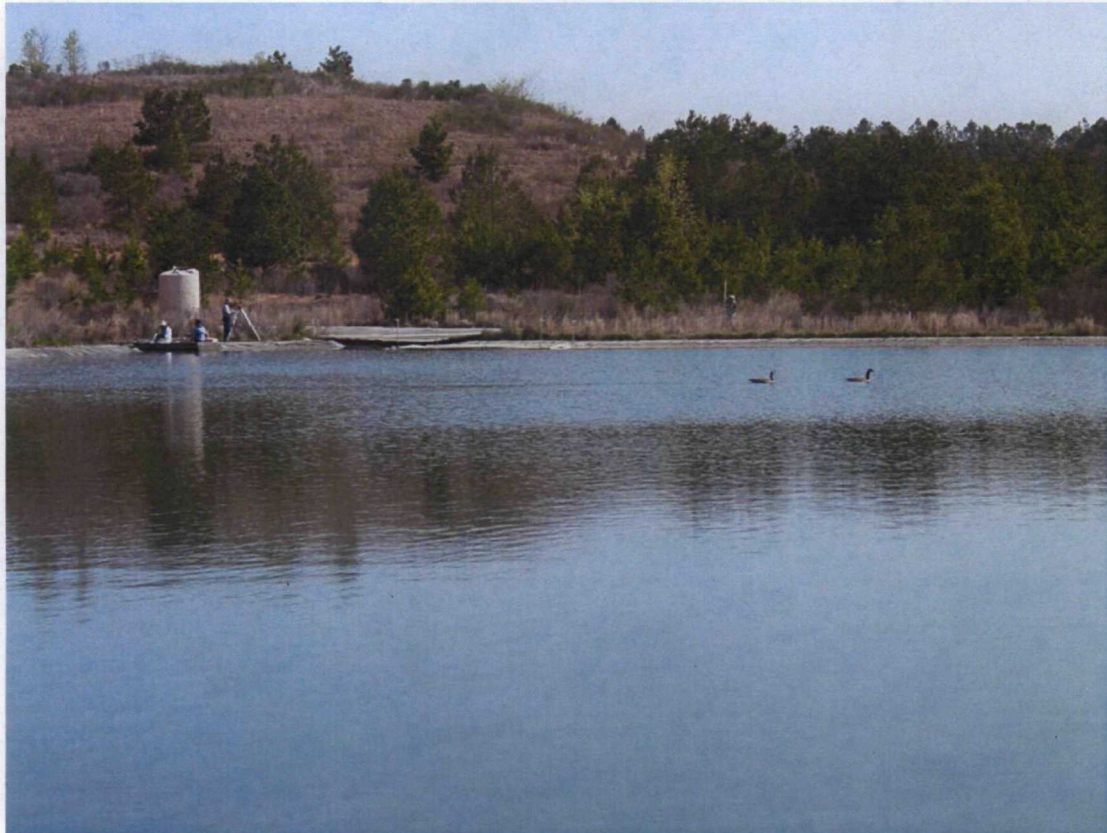
Constructed in January 1992, this pond covers nearly 2.5 acres. It has a capacity of 5,500,000 gallons. Originally used to contain barren solution, this pond receives seepage flows from the Landfill Repository via a buried drainage pipeline. The pond is full and it will likely turn acid in the future.

**Figure 60. Permanent Pad Barren Pond is the largest of the lined impoundments. The Canadian Geese had a nest on the side of the pond which contained two eggs.**

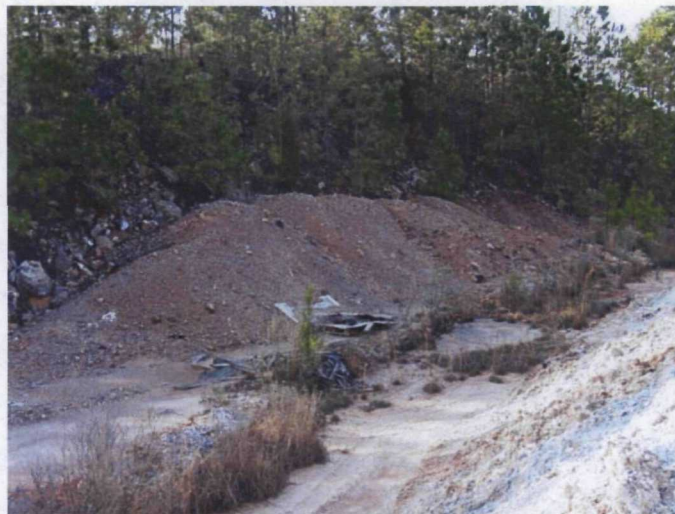
Figure 61. Small pile of topsoil remaining in the Topsoil Stockpile Area.

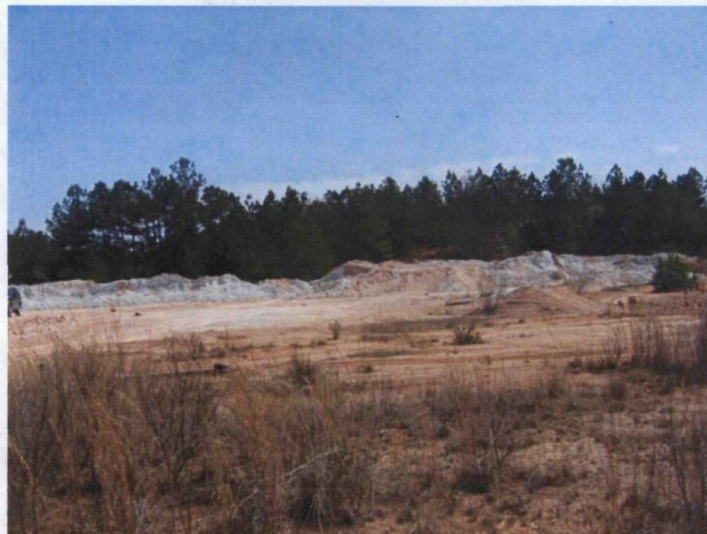
Figure 62. Slaked lime stockpile is a valuable resource.

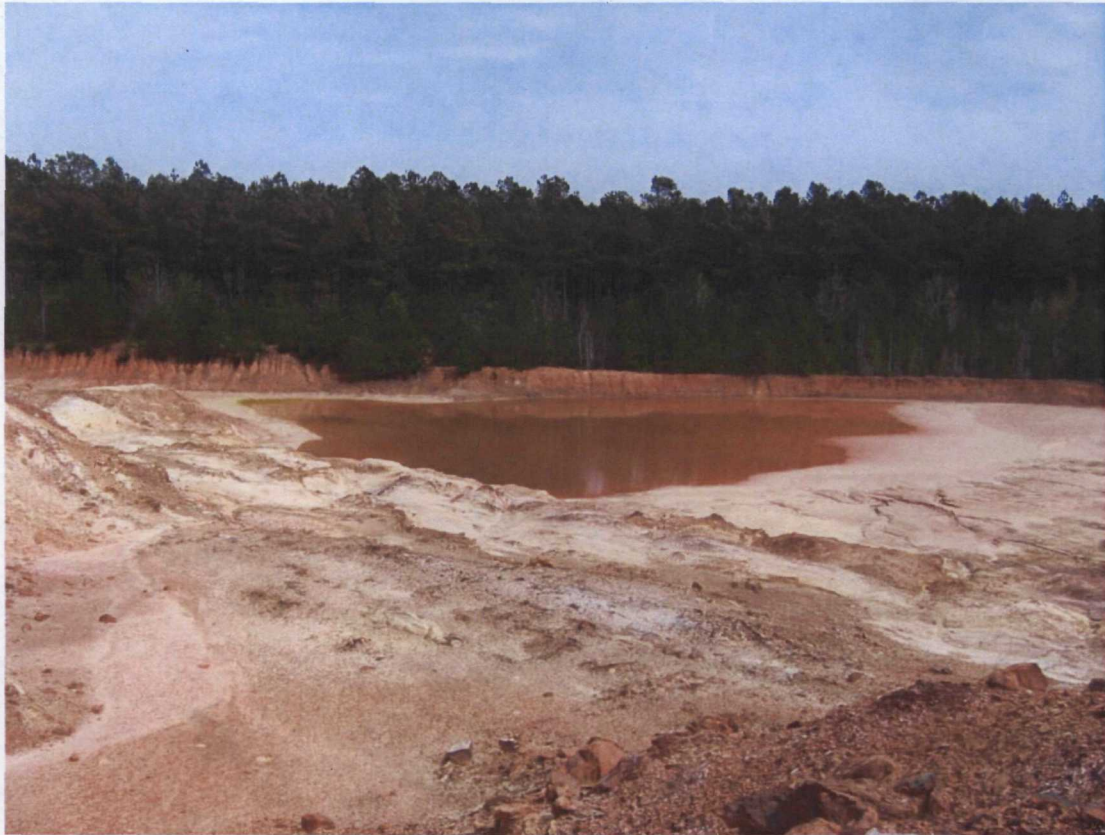
The Clay Soil Borrow Pit is an area of the site from which clay was removed for use in constructing the clay caps over the waste rock and spent ore repositories. This pit does not have any drainage outlet, so water ponds in the area and slowly seeps into the ground. It is possible that this seepage is flowing into the adjacent Barite Hill Pit. This area needs to be reclaimed. No drawings were found for this area. The disturbance is roughly estimated to be 4 acres in size.

**Figure 63. Photograph of the Clay Soil Borrow Pit.**

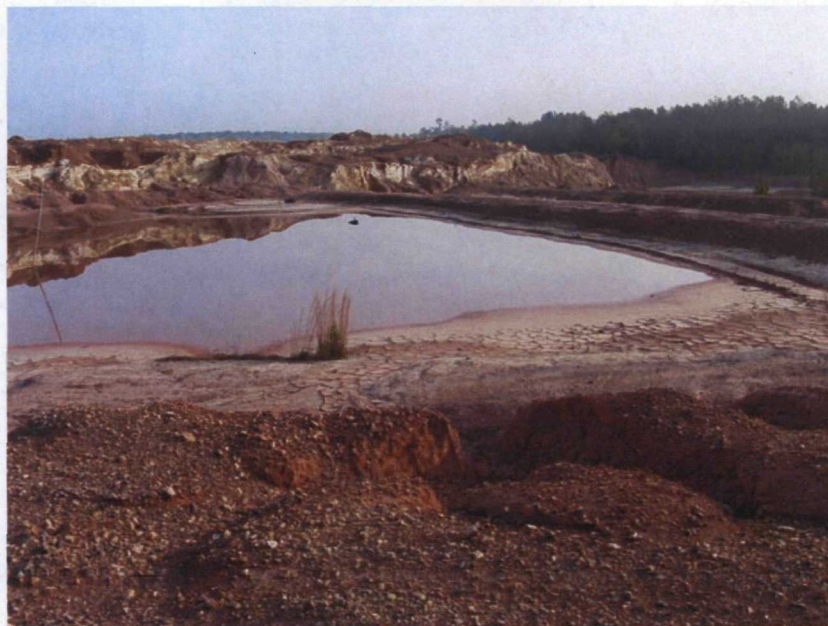
The sediment pond is located in a area of 1.9 acres of disturbance. It includes a fill embankment which retains the reservoir. The embankment has no spillway. What appears to be good quality water is impounded behind the embankment. This pond is of more value for the water it captures and stores than its function as a sediment control feature. The water can be used for dust control and washing down equipment used in site reclamation work.

**Figure 66. Sediment Pond located south of the Barite Hill Pit.**

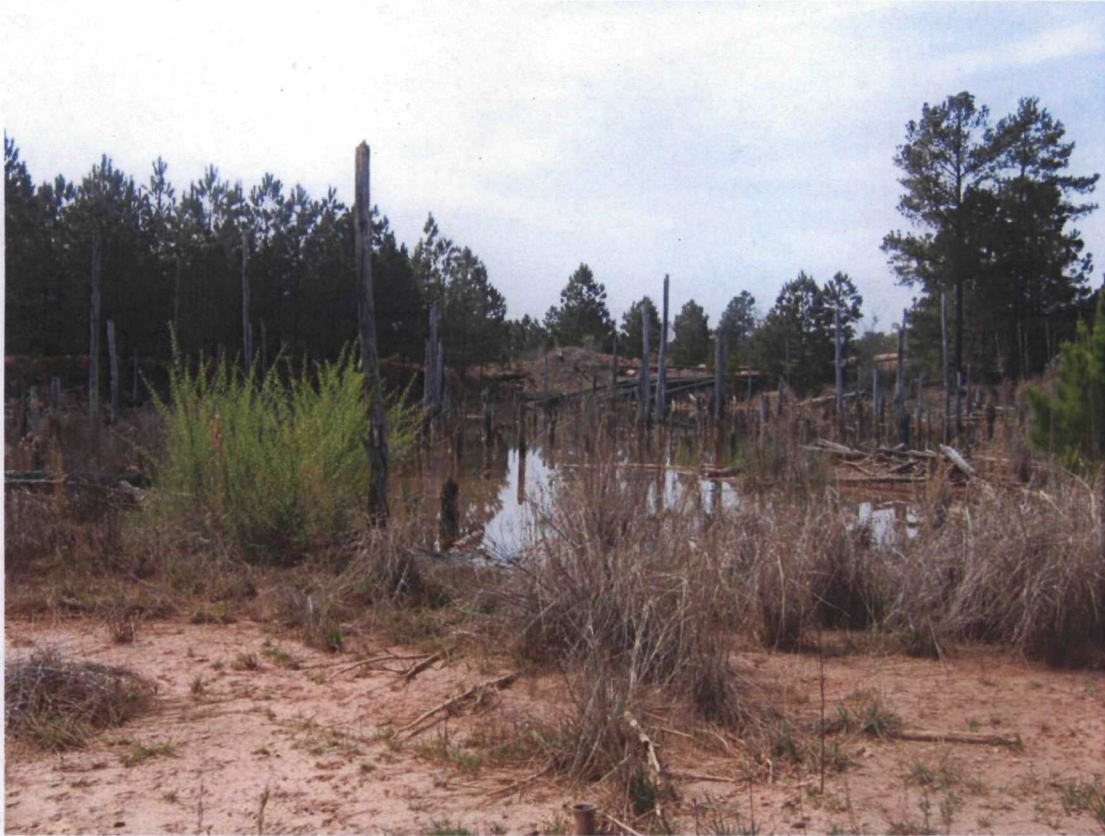
Two wetlands/pond areas have formed on the site. One area which appears to be a pond with wetland vegetation is northeast of the former crusher area. The other area is more of a pond which formed as a result of the access ramp being constructed to the Industrial Solid Waste Landfill. This area is on the northwest side of the landfill. It is not known if the water from this ponding is affecting the landfill and it needs further evaluation.

**Figure 67. Ponding area adjacent to the Industrial Solid Waste Landfill.**

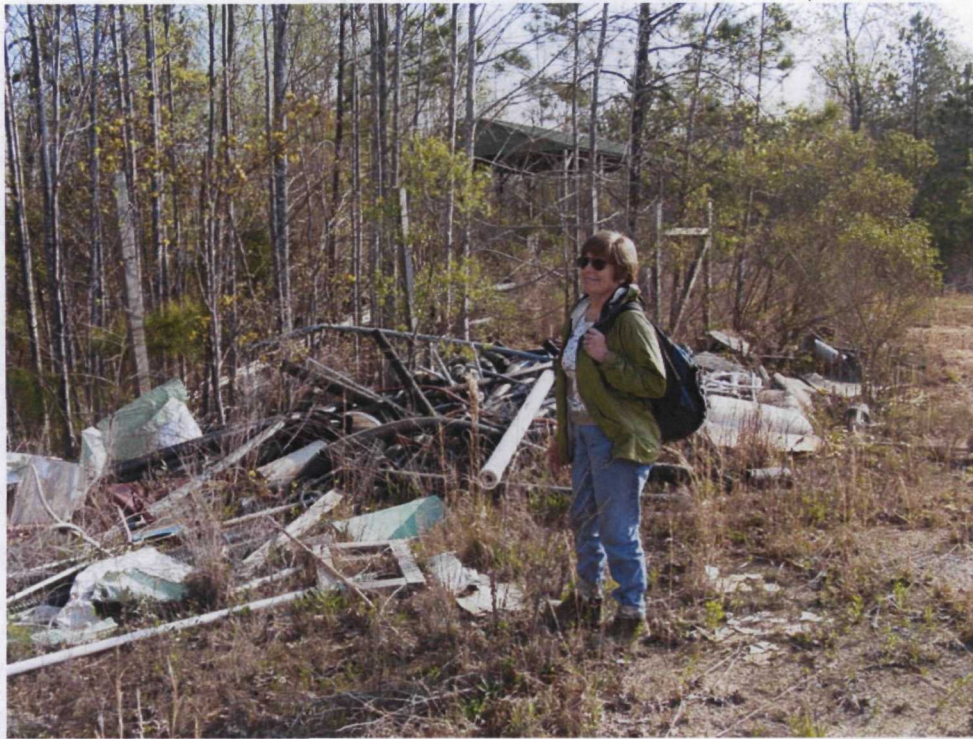
A few debris piles were found at the site. Next to the contingency pond is a pile of geonet drain. The debris in the Pole Barn has already been described. There are two piles of debris outside this structure containing wood, metal pipe, plastic pipe, sheet metal and rubber. Near the mine office is a pile of rusted metal and several piles of pipe segments. HDPE pipe segments are present in one of the piles. The HDPE pipe should be retained for future use. Other types of plastic pipe have deteriorated from exposure to sunlight and should be disposed.

**Figure 69. Debris pile near the Pole Barn.**

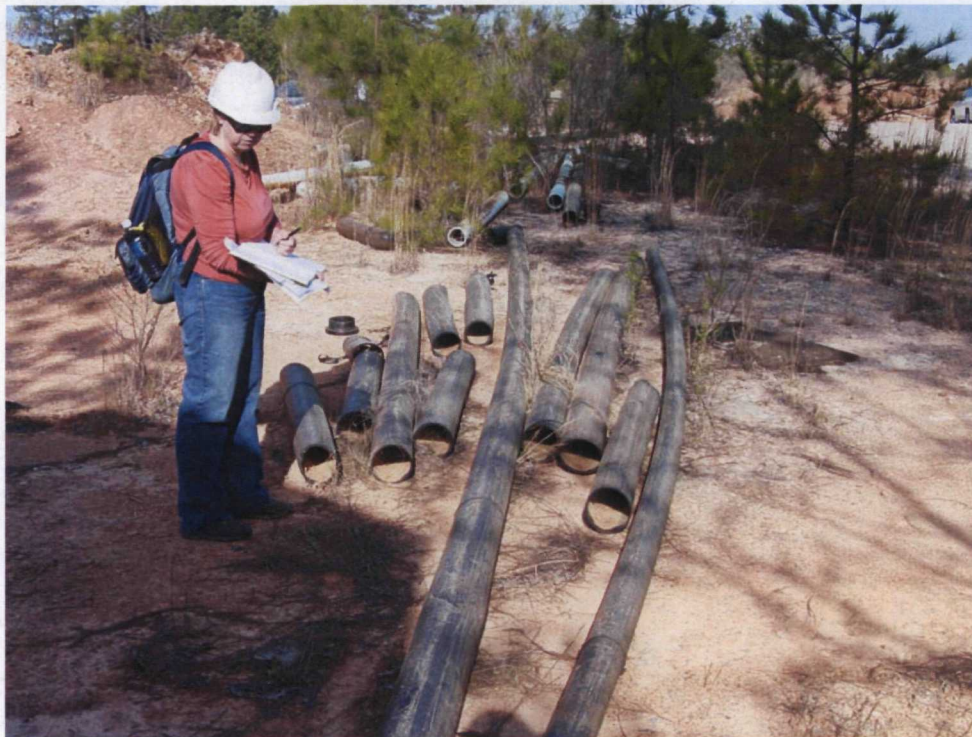
**Figure 70. Piles of pipe located near the Mine Office. The HDPE pipe in the foreground should be retained. Pipe in the background is of no value.**
